Continuing Rehabilitation and Upgrade of PCED

JULIE ANNE B. CAIMOL buildings (Phase 4), UP Dilinon, Quezon City

CRACK REPAIR ALONG RECTANGULAR PIPE SLEEVE

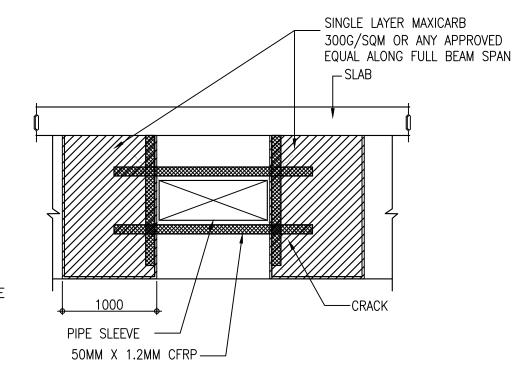
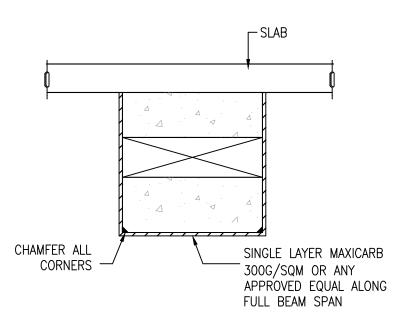
CRACK REPAIR ALONG
RECTANGULAR PIPE SLEEVE

THIS REPAIR METHODOLOGY IS APPLICABLE FOR 2ND FLOOR TO 3RD FLOOR BEAMS (ABOVE AUDITORIUM AND 2ND FLOOR BEAMS)

REPAIR METHODOLOGY FOR CRACKS ALONG RECTANGULAR PIPE SLEEVES:

1. CLEAN THE CRACKS AND SURROUNDING AREA TO REMOVE DUST, LOOSE MATERIAL, OR ANY CONTAMINANTS. ENSURE SURFACES ARE DRY BEFORE APPLICATION OF EPOXY GROUT.

- 1. DRILL ENTRY AND EXIT PORTS: DRILL 3 MINIMUM DIAMETER INJECTION HOLES. SPACING OF HOLES SHOULD NOT BE GREATER THAN 500mm FROM EACH OTHER.
- 2. SEALING THE CRACKED SURFACE: APPLY A SEALING COMPUND OVER THE CRACK TO PREVENT THE EPOXY FROM LEAKING OUT.
- 3. INJECT EPOXY: INJECT SIKADUR-752 OR ANY APPROVED EQUAL INTO THE DRILL PORTS UNTIL IT FLOWS OUT OF THE ADJACENT PORT, ENSURING THE ENTIRE CRACK IS FILLED.
- 4. CURING: ALLOW THE EPOXY TO CURE ACCORDING TO THE MANUFACTURER'S SPECIFICATIONS.

- 1. APPLY 50mm X 1.2mm CFRP PLATE AT EACH SIDE OF THE PIPE SLEEVE, EXTENDING AT LEAST 250MM FROM BOTH SIDES OF THE CRACKED CORNER.
- 2. APPLY CFRP, 300G/SQM, EXTENDING 1000mm FROM BOTH SIDES OF THE SLEEVES.
